Beach Nourishment Report

Park Point Beach Tour

Nov. 19, 2020; 2:30 PM - 4:30 PM

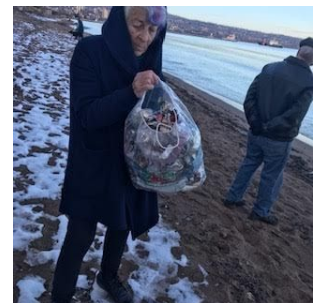
13th - 11th st.: The group walked this stretch and fanned out across the beach. Considerably more crushed aluminum pieces were found along the water's edge in this area. Most often it was found in a mixture of small pieces of wood and other debris. The group collected enough pieces of aluminum ranging in size from tiny (.25") to large (half of an aluminum can) to fill approximately half of a gallon plastic bag. The group did not detect odors, nor did they observe oil in the sand or water. Water was calm and clear of turbidity. Some clumps of sand were found that looked like clay, but they could be easily broken up with fingers.
